Geology and Soil Discipline Report

GEOLOGY AND SOIL DISCIPLINE REPORT
La Brea Tar Pits Museum Master
Plan Project
5801 WILSHIRE BOULEVARD, LOS ANGELES, CALIFORNIA

Subject: GEOLOGY AND SOIL DISCIPLINE REPORT, LA BREA TAR PITS MUSEUM
MASTER PLAN PROJECT, 5801 WILSHIRE BOULEVARD, LOS ANGELES,
CALIFORNIA

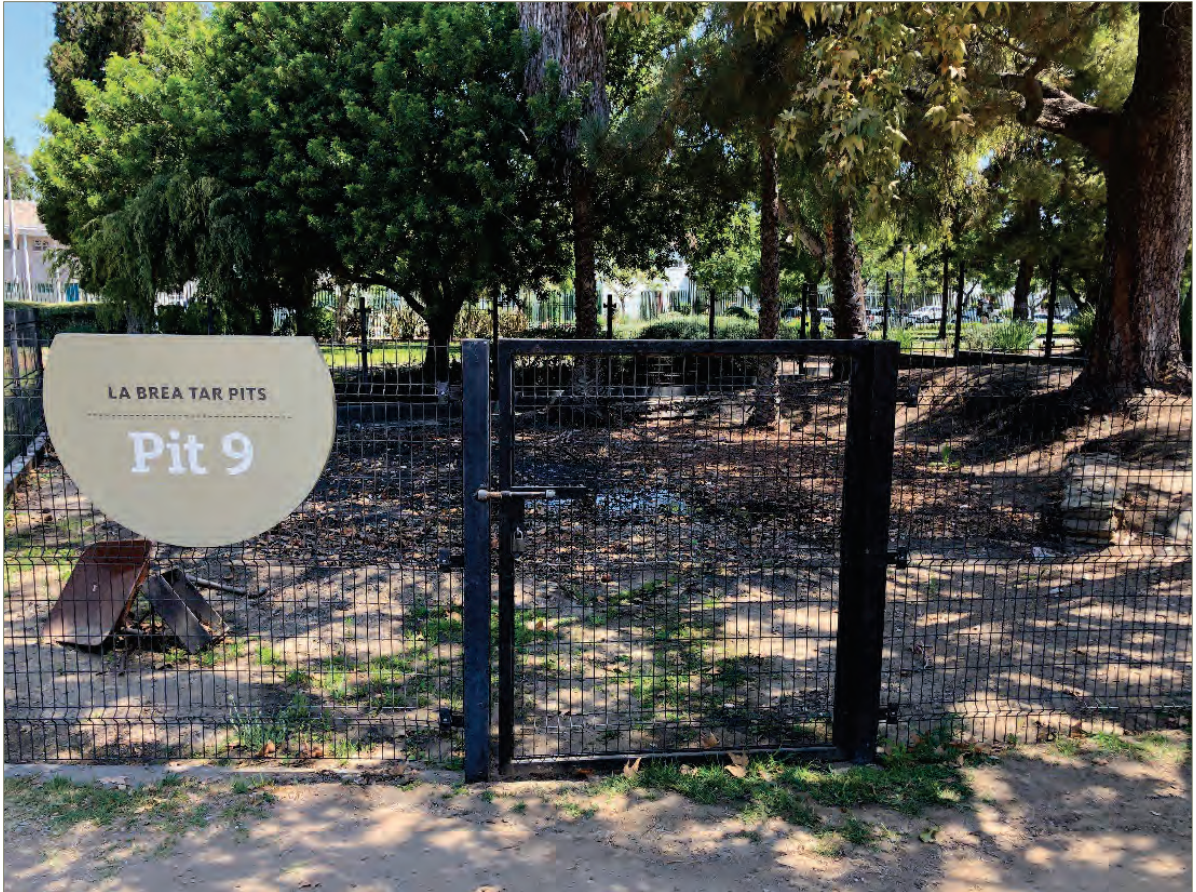
Exhibit 2-1: A Tar Pit Exhibit Within Hancock Park (View Towards North)

Multiple tar pit excavations are located within the park, and natural tar seeps occur randomly throughout the park and the parking lot. The park contains pedestrian pathways, recreational areas, and landscape features. The Page Museum is located within the central-eastern portion of the site. Other features include Lake Pit at the southern portion of the site, an existing at-surface parking lot at the northeastern portion of the site, and a public restroom and comfort station at the southeastern portion of the site. Exhibit 2-1 below shows a tar pit exhibit located within the northwestern portion of Hancock Park.

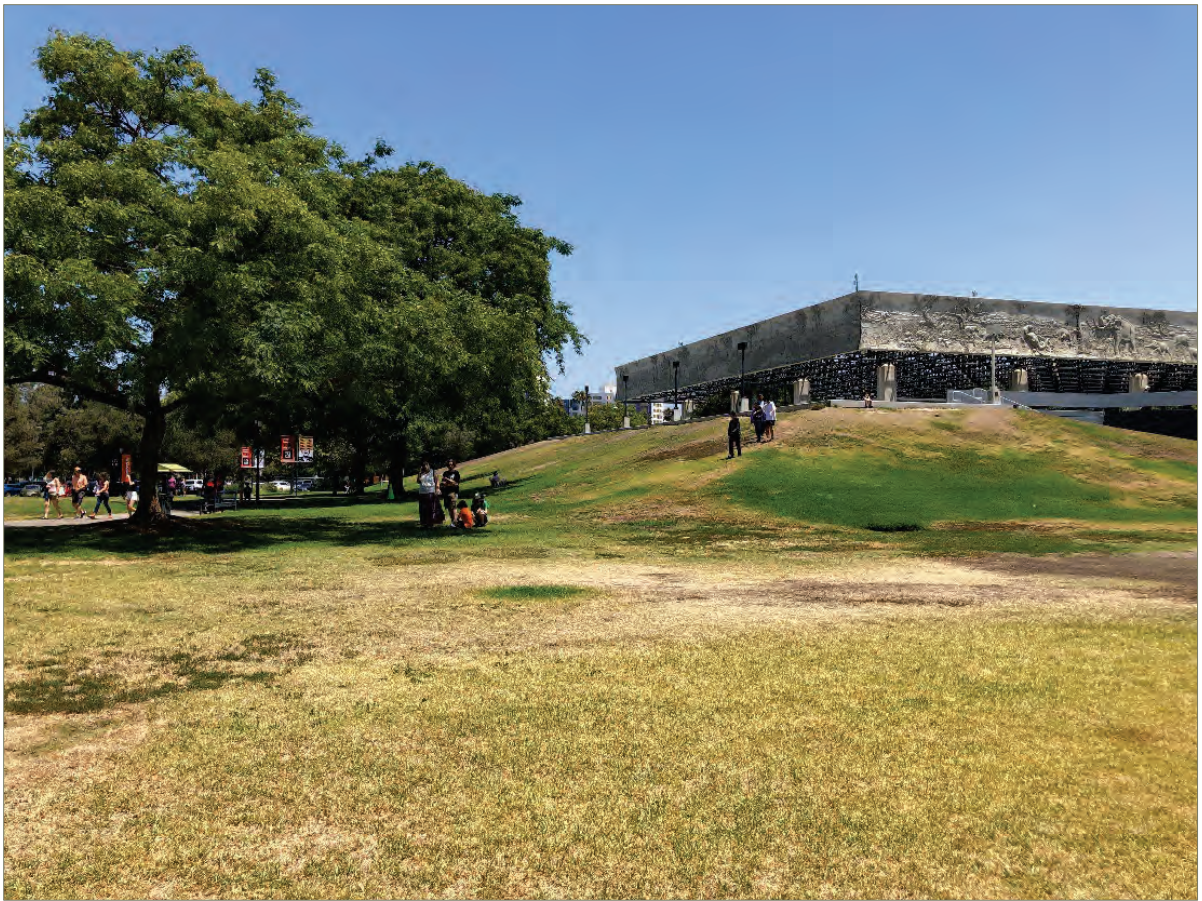
Exhibit 2-2: Existing Side Slopes Surrounding the Museum (View Towards Northeast)

The existing Page Museum is a one-story structure with an accessible roof terrace. Per the “Structural Engineering” sheets prepared by MKA, we understand the structure measures 260 feet in the east-west direction and 230 feet in the north-south direction. On all sides of the structure, the outer 40 feet slopes downward from the upper roof terrace and extends to approximately 6 feet above the first-floor slab at the building perimeter. The sloped section is covered with approximately 12 inches of landscape.

The base of the ground floor is below the surrounding natural grade, embedding the building beneath the surrounding ground surface. The ground floor consists of an atrium within the center, which contains tropical plants and water features, and interior exhibit space housing the La Brea Tar Pit fossils surrounding the atrium. The roof terrace allows visitors to look down into the atrium and provides a view of the surrounding park. Based on the “Structural Engineering” sheets prepared by MKA, we understand the museum's existing foundation consists of a 30-inch-thick reinforced concrete mat slab that covers the entire footprint of the building. The mat slab steps down 4.5 feet within the interior atrium area. Exhibits 2-2 and 2-3, presented below, show the existing outside and inside condition of the Page Museum.

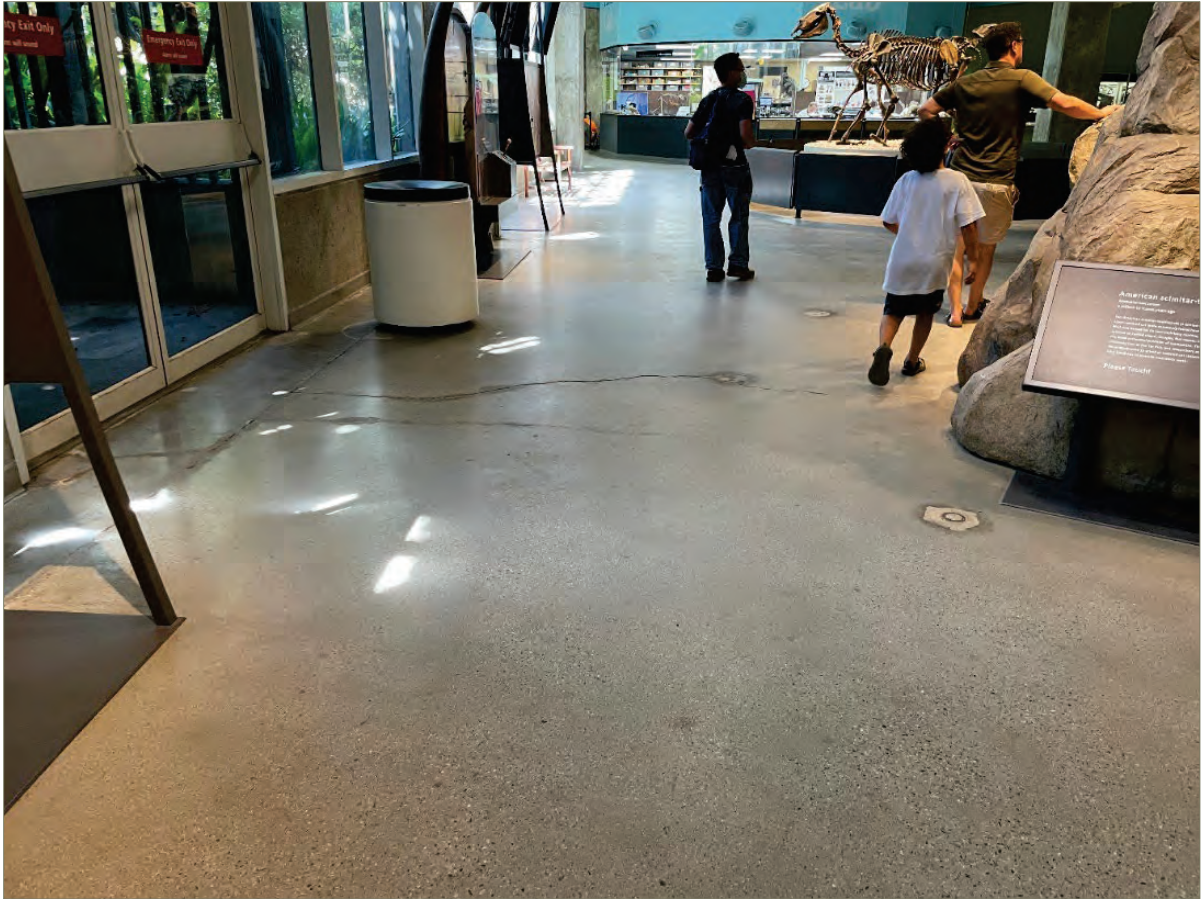
Exhibit 2-3: Eastern Exhibit Within the Museum (View Towards North)

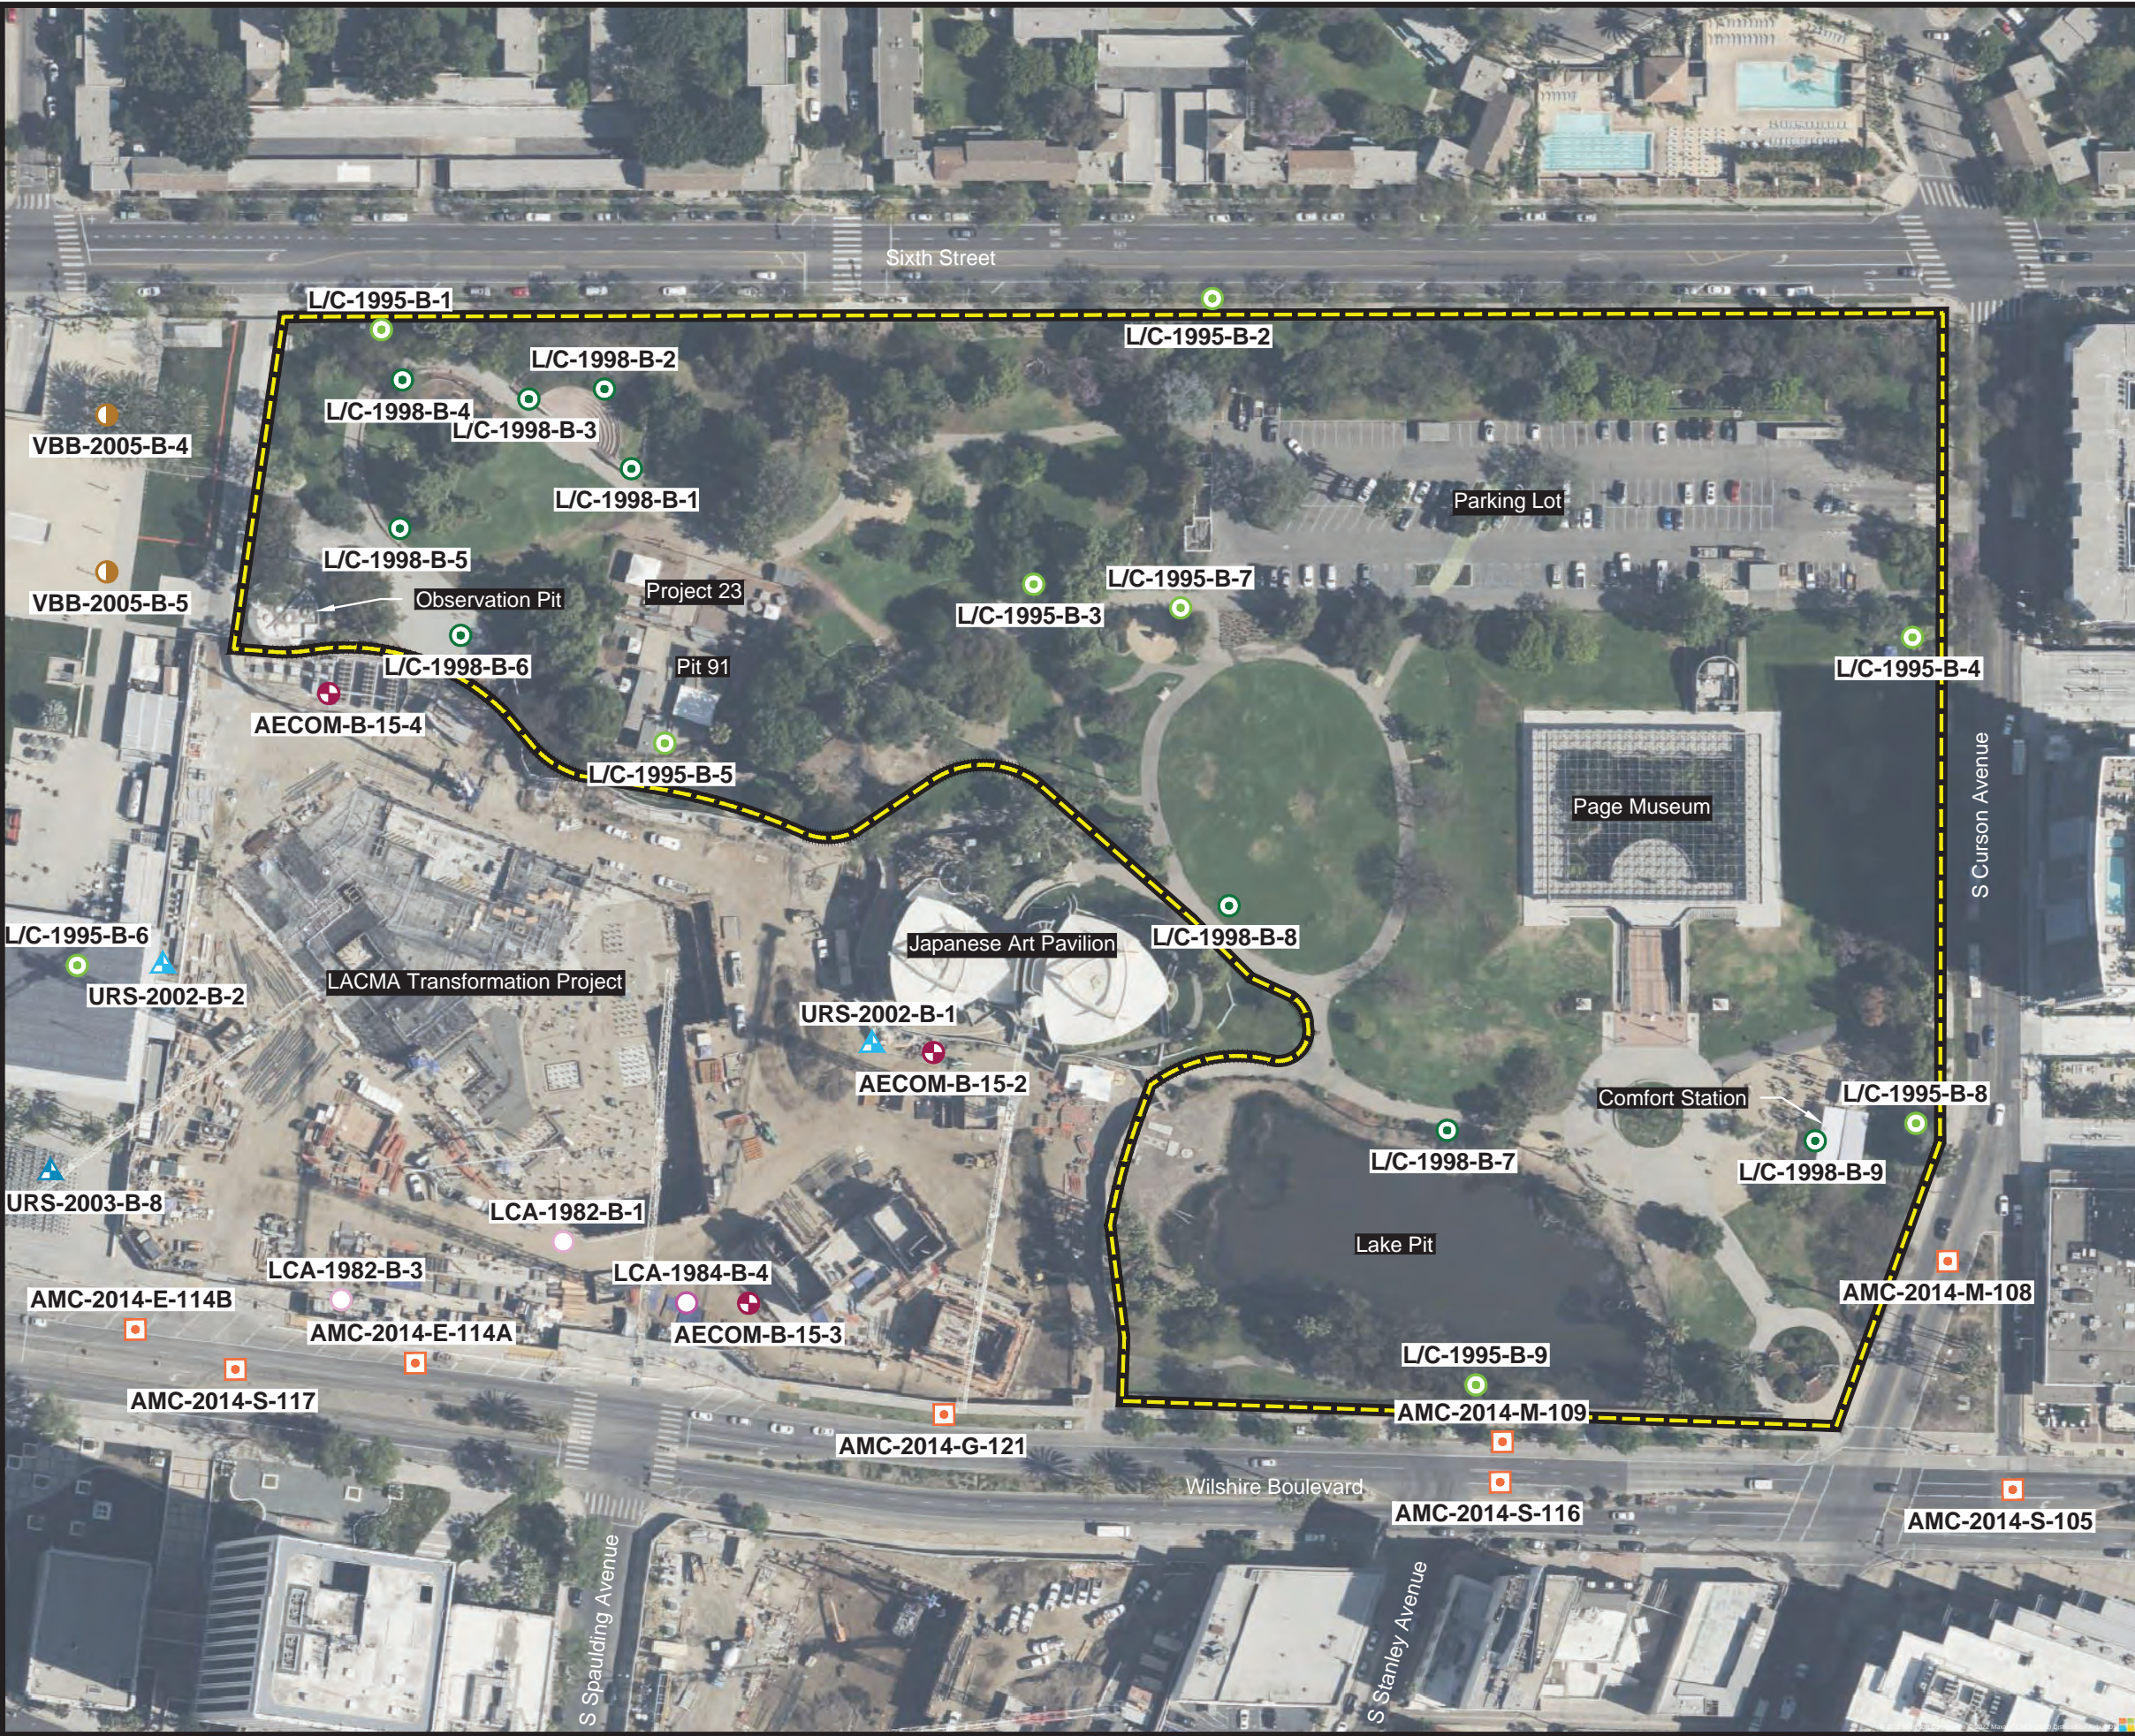
La Brea Tar Pits Museum Master Plan Hancock Park Los Angeles, California	
SITE PLAN	
January 2023	109748-001
	FIG. 2

- Approximate Limit of Work
- Boring Designation and Approximate Location (AECOM, 2019)
- Boring Designation and Approximate Location (Metro GDR, 2014)
- Boring Designation and Approximate Location (Van Beveren & Butelo, 2005)
- Boring Designation and Approximate Location (URS, 2003)
- Boring Designation and Approximate Location (URS, 2002)
- Boring Designation and Approximate Location (Law-Crandall, 1998)
- Boring Designation and Approximate Location (Law-Crandall, 1995)
- Boring Designation and Approximate Location (LeRoy Crandall, 1984)
- Boring Designation and Approximate Location (LeRoy Crandall, 1982)

The Project is located at 5801 Wilshire Boulevard within the City of Los Angeles (City), as shown in the Vicinity Map, Figure 1, and the Site Plan, Figure 2. The Project consists of proposed improvements in an approximately 13-acre area within the eastern and northwestern portions of Hancock Park. This area includes the exhibits for the La Brea Tar Pits. The site is bounded by the Los Angeles County Museum of Art (LACMA) Campus to the west, Wilshire Boulevard to the south, Sixth Street to the north, and South Curson Avenue to the east.

The geologic hazards and recommendations are based on the results of our prior subsurface explorations and explorations by others listed below. Relevant boring logs prepared by S&W and VB&B are presented in Appendix A. Relevant boring logs prepared by others are presented in Appendix B.
